Paxe Latitude LP

SUPPLEMENTAL AFFIDAVIT OF ARIC SCHMITTER

: CEOS Aric Schmitter Document Page 3 of 36 525 Sawyer Blvd - 2022 EVH 060061 - 2023 EVH 060373 - August 4, 2023 - Aric Schmitter

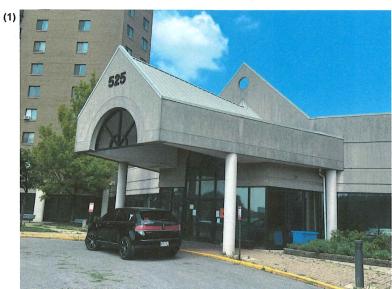
Structure not boarded and secured to code. High grass and/or weeds in excess of 12 inches. A crew was on site cutting the grass, but there are multiple sections that remain uncut. 4707.01, 709.03

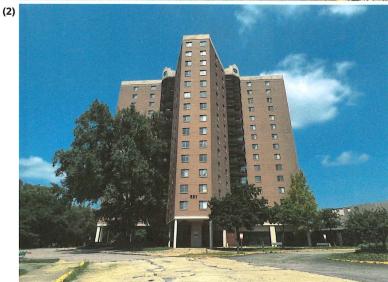
Structure not boarded and secured to code. Boards covering windows/doors not painted. Damaged concrete and asphalt present in multiple areas of the parking lot and circulation areas. Damaged concrete present on multiple areas of the curbs/sidewalks. 4707.01, 4525.11

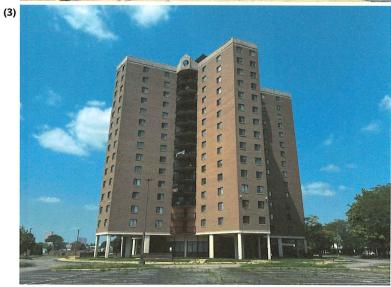
Structure not boarded and secured to code. Boards covering windows/doors not painted. Damaged concrete and asphalt present in multiple areas of the parking lot and circulation areas. 4707.01, 4525.11

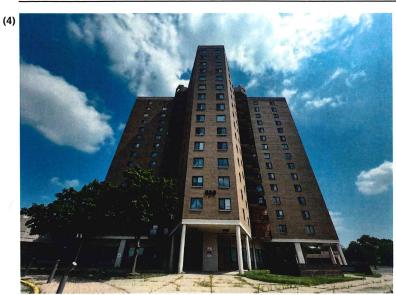
Structure not boarded and secured to code. Boards covering windows/doors not painted. Damaged metal pylon. 4707.01, 4525.11

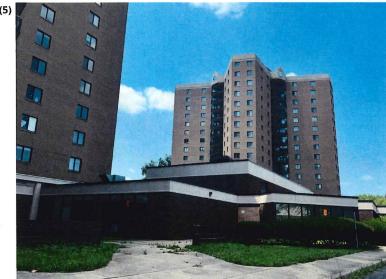
Structure not boarded and secured to code. Multiple open windows; leaving the interior open to the elements. Boards covering windows/doors not painted. 4707.01

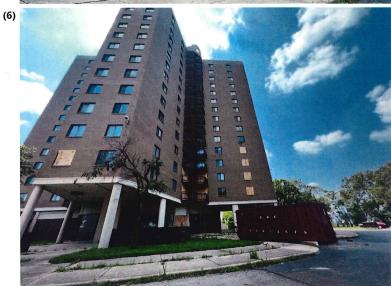
Solid waste present on multiple areas of the property. Damaged concrete present on the multiple areas of the property including the dumpster pad and sidewalk. Property lacking zoning clearance for the storage of a dumpster. Structure not boarded and secured to code. Boards covering the windows/doors not painted. 707.03, 4525.14, 4707.01

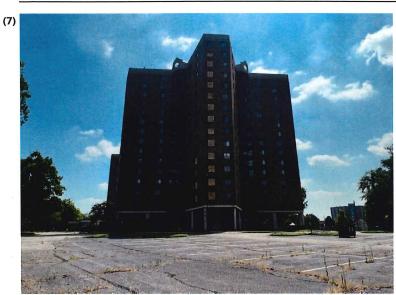
Structure not boarded and secured to code. Boards covering the windows/doors not painted. The exterior trash chute that was installed on the 521 tower has been removed. Property lacking zoning clearance for the storage of a dumpster. 4707.01

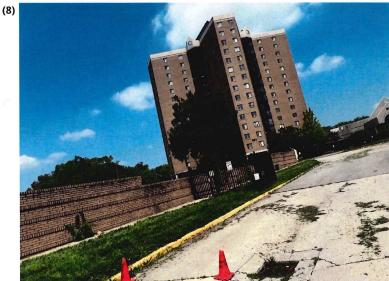
Structure not boarded and secured to code. Boards covering windows/doors not painted. Damaged concrete and asphalt present in multiple areas of the parking lot and circulation areas. 4707.01, 4525.11

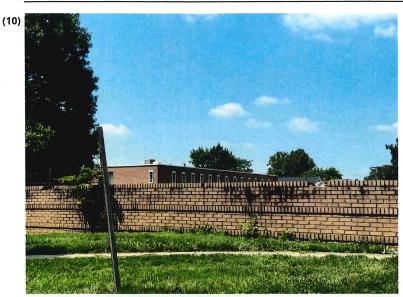
Damaged brick and mortar voids in the perimeter wall present on multiple areas of the property. 4525.14

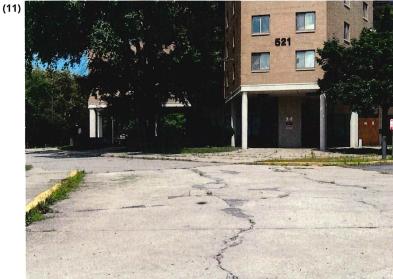
Structure not boarded and secured to code. Boards covering windows/doors not painted. Damaged concrete and asphalt present in multiple areas of the parking lot and circulation areas. 4707.01, 4525.11

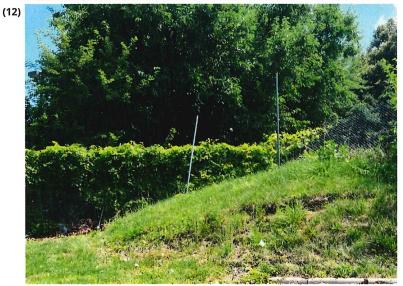
High grass and weeds in excess of 12 inches present on multiple areas of the property. Damaged sections of fencing present on multiple areas of the property. 709.03, 4525.13

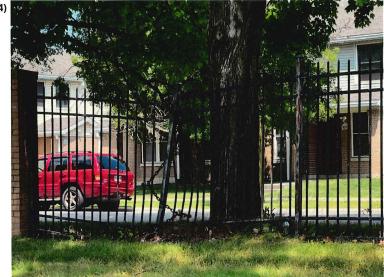
Damaged sections of fencing present on multiple areas of the property. 4525.13

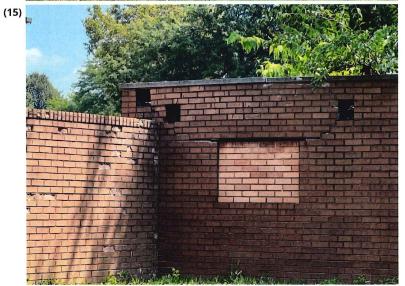
Damaged brick and mortar voids in the perimeter wall present on multiple areas of the property. 4525.14

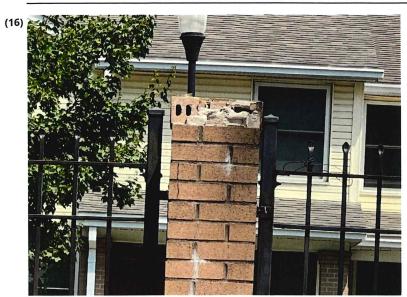
Damaged brick and mortar voids in the perimeter wall present on multiple areas of the property. 4525.14

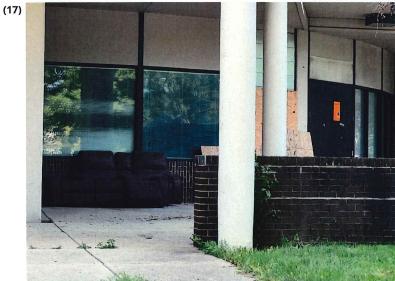
Solid waste present on multiple areas of the property. Structure not boarded and secured to code. Boards covering the windows/doors not painted. 707.03, 4707.01

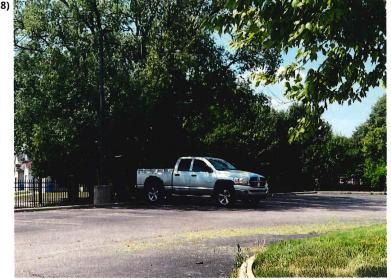
Inoperable vehicle with an expired registration sticker stored on the south side of the property. 3312.37

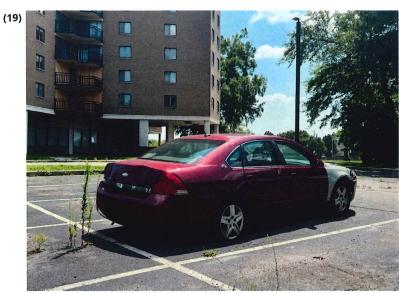
Inoperable vehicle with an expired registration sticker stored on the west side of the property. Damaged concrete and asphalt present in multiple areas of the parking lot and circulation areas. Structure not boarded and secured to code. Boards covering windows/doors not painted. 3312.37, 4525.11, 4707.01

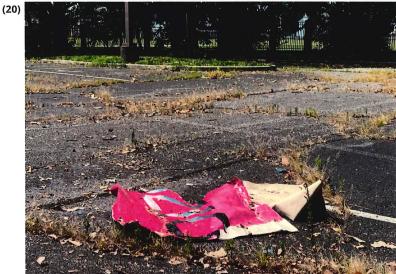
Solid waste present on multiple areas of the property. Damaged asphalt in multiple areas of the parking and circulation areas. 707.03, 4525.11

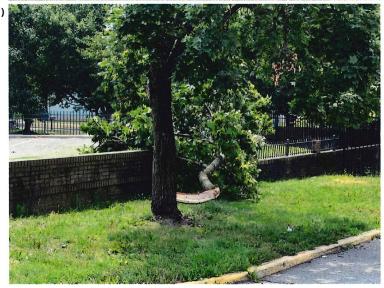
Damaged tree branch present at the front gate. 4525.11

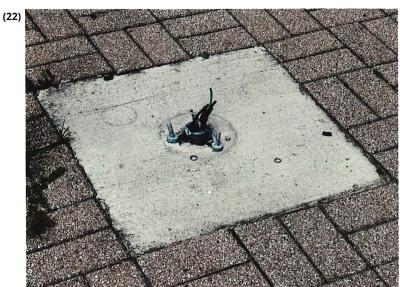
Metal pylon has been removed exposing bare electrical wires. 4523.04

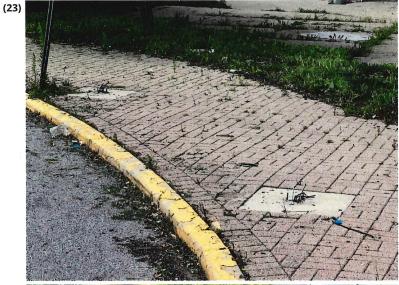
High grass and weeds in excess of 12 inches present on multiple areas of the property. Metal pylon has been removed exposing bare electrical wires. 709.03, 4523.04

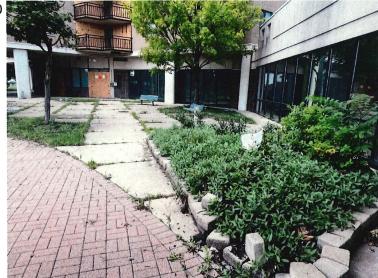
High grass and weeds in excess of 12 inches present on multiple areas of the property. Structure not boarded and secured to code. Boards covering the windows/doors not painted. 709.03, 4707.01

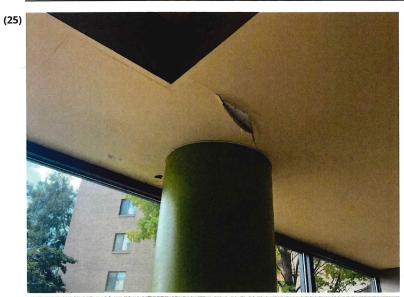
Active ceiling leak and damaged drywall material in the 521 tower hall. 4525.12

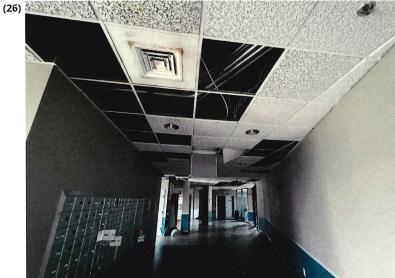
Multiple missing/damaged ceiling tiles in the 521 tower hall. 4525.12

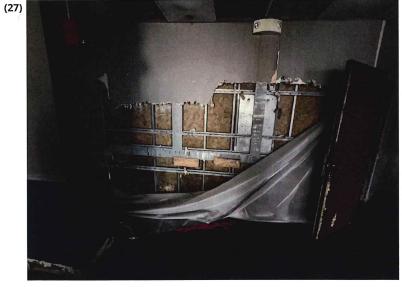
Missing damaged sections of wall material in the 521 tower hall. 4525.12

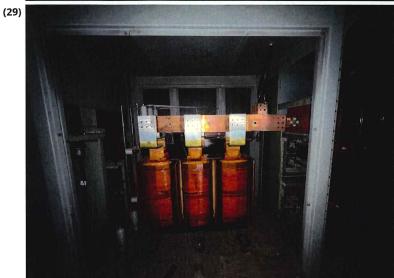
Electrical components present in the sprinkler riser room of the 521 tower have been removed and vandalized. There are multiple areas of the 521 building that show signs of electrical components that have been removed. 4523.04

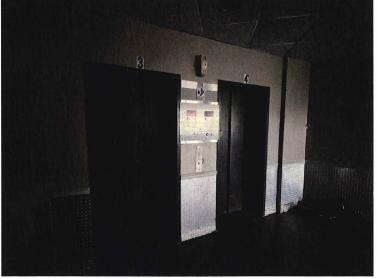
Elevators present in the 521 tower have been red tagged by the state of Ohio Dept Of Commerce elevator inspector. 4525.05

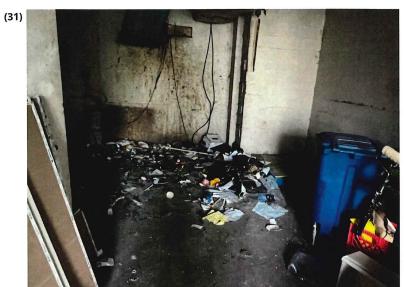
Unsanitary conditions and solid waste present in the 521 maintenance area at the interior trash chute. 705.03, 707.03

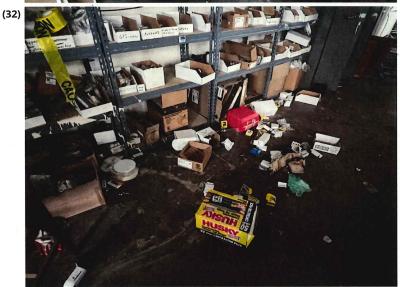
The maintenance area present in the 521 tower has been broken into and vandalized.

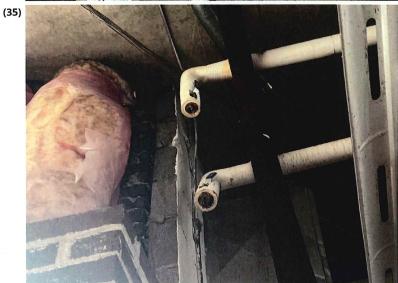
Plumbing lines present in the maintenance area of the 521 tower have been removed and vandalized. There are multiple areas of the 521 building that show signs of plumbing that have been removed. 4521.08

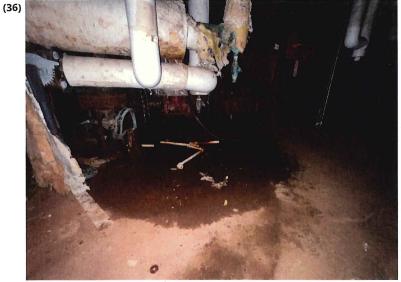
Active leak present in the 521 tower sprinkler riser room. 4521.08

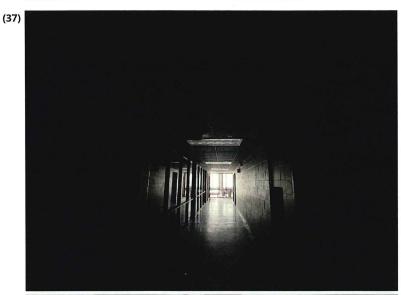
Active roof leak and damaged ceiling material present in the hall at the gymnasium. Damaged floor material present in the gymnasium hall. 4525.12

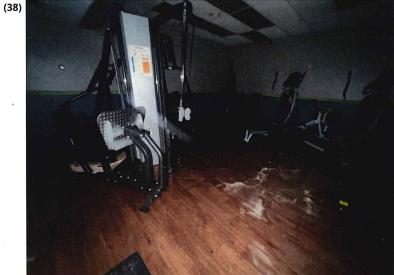
Active roof leak and damaged ceiling material present in the workout room. 4525.12

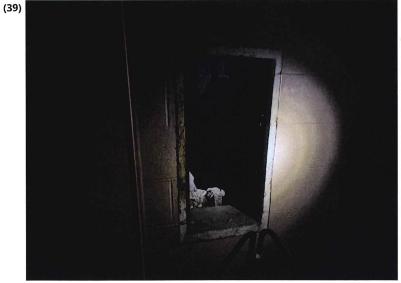
Damaged concrete block present in the gymnasium hall. 4525.14

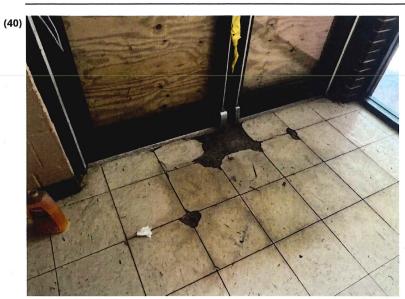
Damaged flooring present in the hall at the northwest corner of the gymnasium hall. 4525.12

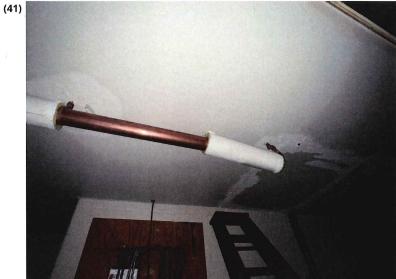
Plumbing lines present in the storage room of the gymnasium have been removed and vandalized. There are multiple areas of the building that show signs of plumbing that have been removed. 4521.08

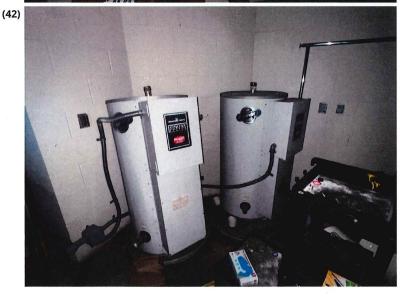
Plumbing lines present in the storage room of the gymnasium have been removed and vandalized. There are multiple areas of the building that show signs of plumbing that have been removed. 4521.08

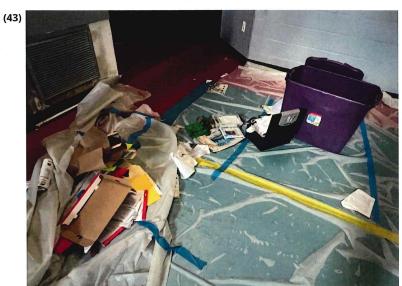
Evidence of theft and vandalism to residents belongings that have been decontaminated.

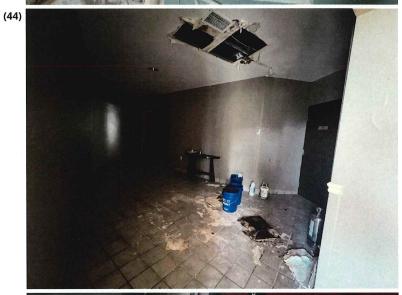
Active roof leak and damaged ceiling material present in the gymnasium hall. Damaged flooring material present in the gymnasium hall. 4525.12

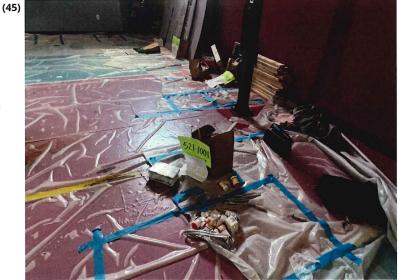
Evidence of theft and vandalism to residents belongings that have been decontaminated.

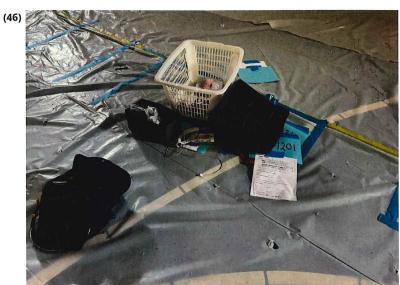
Evidence of theft and vandalism to residents belongings that have been decontaminated.

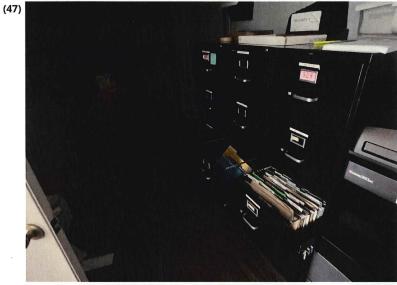
Evidence of theft and vandalism present in the office.

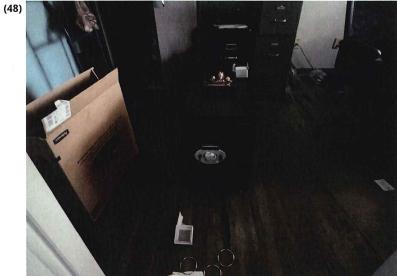
Evidence of theft and vandalism present in the office.

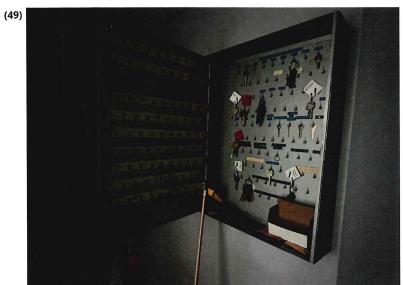
Evidence of theft and vandalism present in the office.

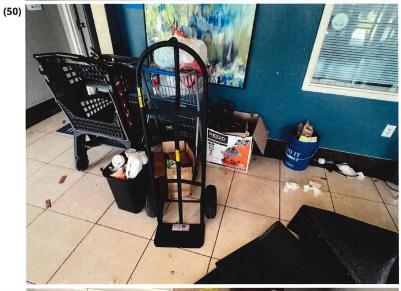
Unsanitary conditions and solid waste present in the building lobby. 705.03, 707.03

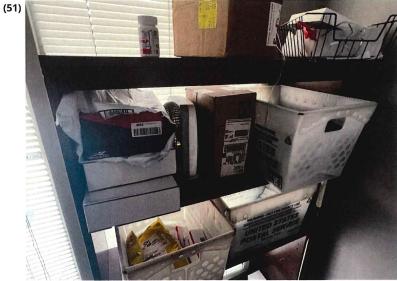
Evidence of theft and vandalism to residents packages that were held in the office.

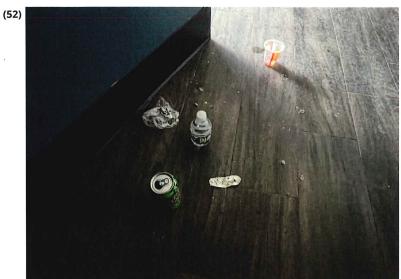
Drug paraphernalia present in the 529 tower hall.

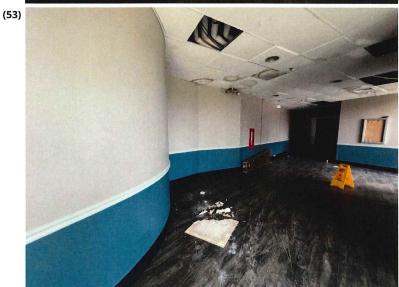
Multiple missing/damaged ceiling tiles present in the 529 tower hall. Active roof leak present in the 529 tower hall. 4525.12

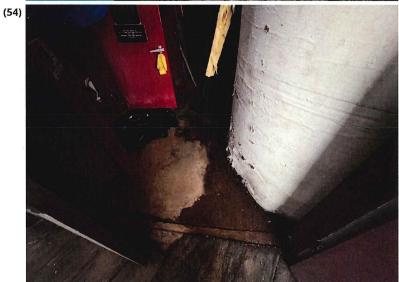
Active leak present in the 529 tower sprinkler riser room. 4521.08

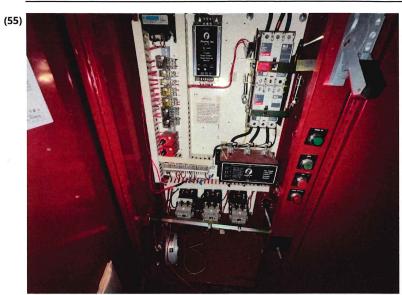
Electrical components of the fire panel present in the 529 tower have been removed and vandalized. There are multiple areas of the 529 building that show signs of electrical components that have been removed. 4523.04

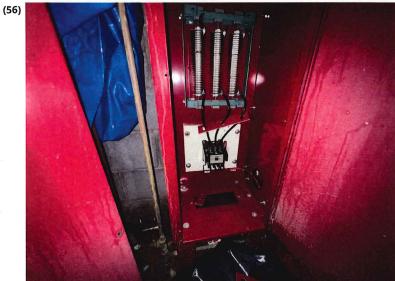
Electrical components of the fire panel present in the 529 tower have been removed and vandalized. There are multiple areas of the 529 building that show signs of electrical components that have been removed. 4523.04

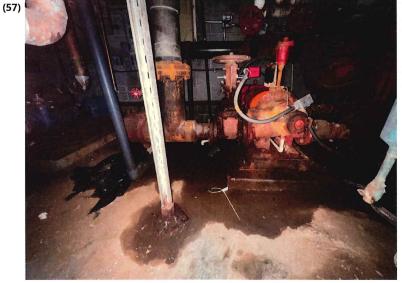
Active leak present in the 529 tower sprinkler riser room. 4521.08

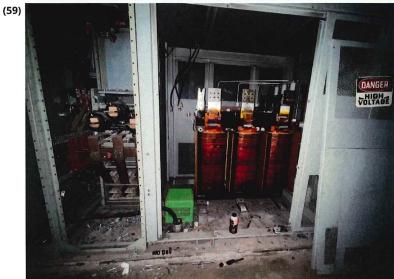
Electrical components present in the 529 tower have been removed and vandalized. There are multiple areas of the 529 building that show signs of electrical components that have been removed. 4523.04

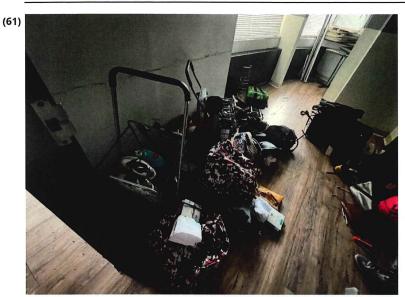
Evidence of theft and storage of resident belongings present in an office of the 529 tower. The exterior door to this room was previously breached and secured by the City of Columbus Environmental Blight Abatement Team on July 26, 2023.

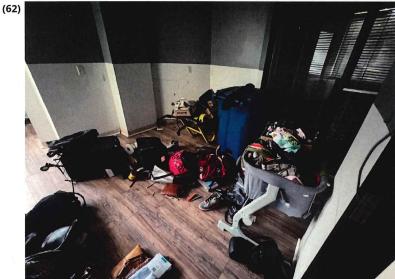
Evidence of theft and storage of resident belongings present in an office of the 529 tower. The exterior door to this room was previously breached and secured by the City of Columbus Environmental Blight Abatement Team on July 26, 2023.

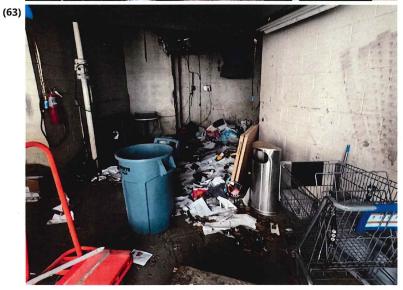
Unsanitary conditions and solid waste present in the 529 maintenance area at the interior trash chute. 705.03, 707.03

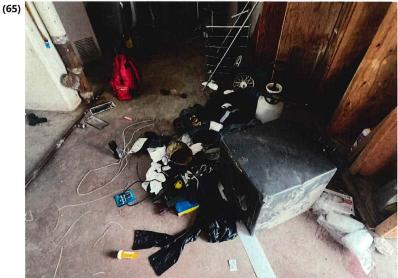
Maintenance area of the 529 tower has been breached and show evidence of theft and vandalism.

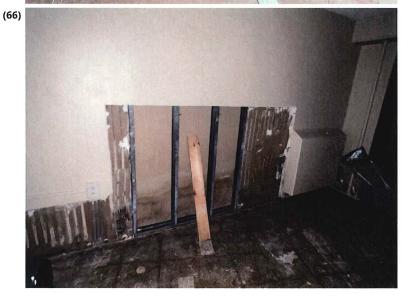
Evidence of mold growth, unsanitary conditions, and missing/damaged drywall material present in multiple areas of the 521 tower. There has been extensive demolition of building components present in multiple areas of both the 521 and 529 towers. 705.03, 4525.12

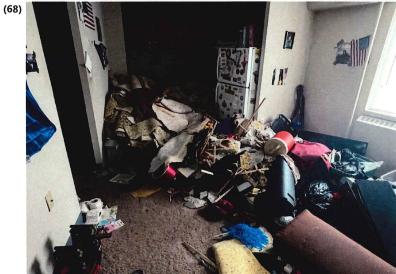
Solid waste, unsanitary conditions, and discarded including building materials asbestos containing materials present in multiple areas of the 521 tower. 705.03, 707.03

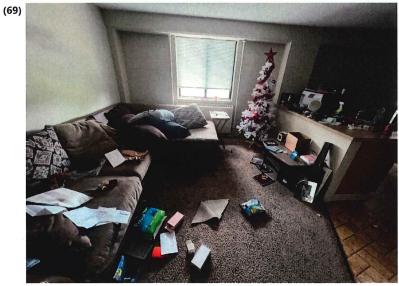
Evidence of theft and vandalism of resident belongings present in multiple apartments of the 521 tower.

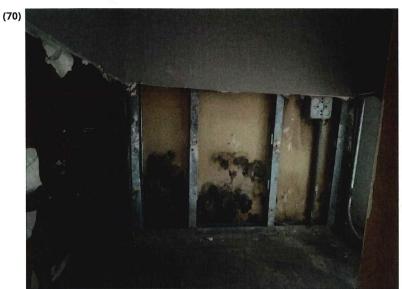
Evidence of mold growth, unsanitary conditions, and missing/damaged drywall material present in multiple areas of the 521 tower. There has been extensive demolition of building components present in multiple areas of both the 521 and 529 towers. Evidence of mold growth, unsanitary conditions, and missing/damaged drywall material present in multiple areas of the 521 tower. 705.03, 4525.12

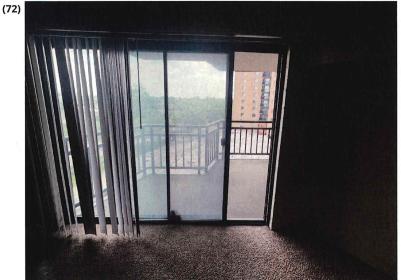
Open sliding glass door present in the 521 tower; leaving the interior open to the elements. 4707.01

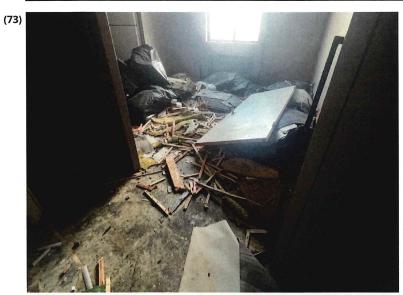
Solid waste, unsanitary conditions, and discarded building materials including asbestos containing materials present in multiple areas of the 521 tower. 705.03, 707.03

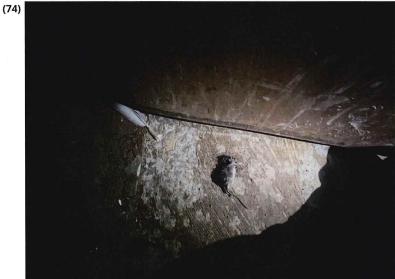
Evidence of active infestation of rodents present throughout both the 521 and 529 towers. 713.03

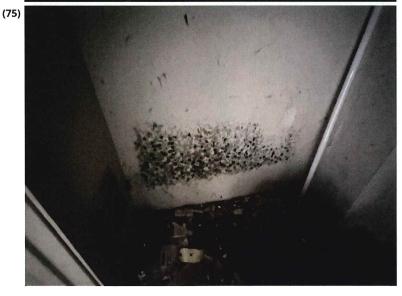
Evidence of mold growth, unsanitary conditions, and missing/damaged drywall material present in multiple areas of the 521 tower.
